EXPERIENCE:
**Ammonia Piping Repair
in Less than 24 hours**

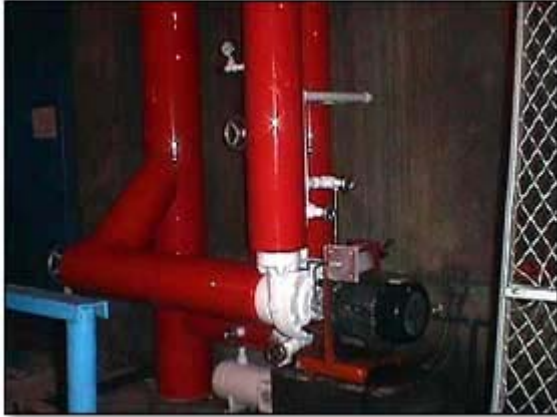
Problem: Minimize downtime during replacement of piping and oil pot within the dock area of an ammonia liquid pump. The customer determined that due to a breakdown in insulation and vapor barrier material, the integrity of the ammonia piping was questionable.

Solution: The objective was to replace the existing piping, valves and have the first layer of insulation installed to minimize downtime for the freezer operation.

The pipe, fittings and valve placement for this project were pre-fabricated on the site. Timing was critical as it included working closely with the insulators to arrive in a timely manner to install the first of two layers of insulation prior to start-up.

The project took less than 24 hours from the start of the pump down, installation of piping and oil pot and fully completing the insulation, including an orange PVC jacket prior to re-starting the system.
