EXPERIENCE:
Overloaded Ice Bank System

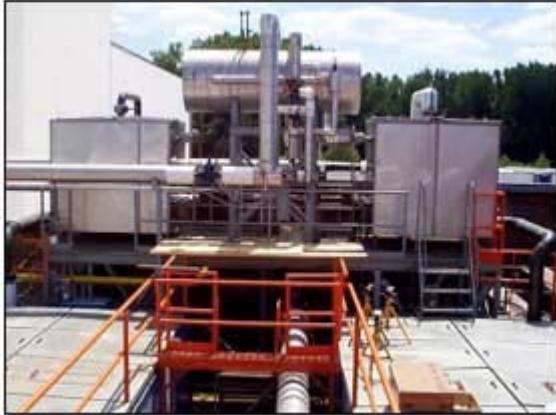
Solution: Project included adding two Chester Jensen heat exchangers to the existing system and removing the ice banks.

All of the water chilled in the Chester Jensen ammonia to water chillers are run into the insulated tanks for storage. With the larger chilled water demand and longer shifts, the ice banks did not have enough ice build time so storage tanks for chilled water were chosen instead.

All ammonia piping and tie-ins were kept to a minimum. We were able to start-up one new chiller while we finished the piping of the second unit and the existing unit. With four chillers now in place and a 7500 gallon storage capacity, the plant has enough chilled water.
